## **A GOVERNMENT INITIATIVE FOR SLUM REHABILITATION**

### **at INDIRA NAGAR COLONY, KHAIRTABAD, HYDERABAD**

**( under Swachhata HI Seva - 2024)**

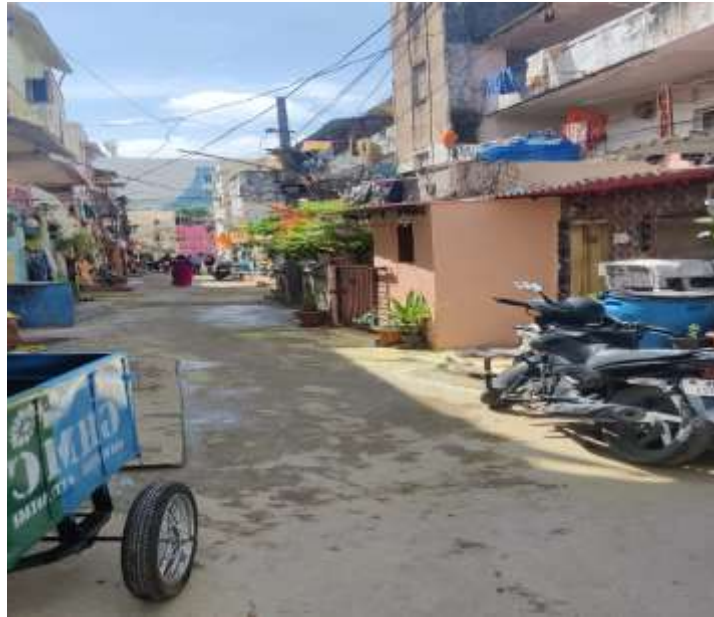
The condition of this area is poor and majority of the people live in kutchha and semi-pukka houses. The situation in terms of socio-economic condition and physical infrastructure namely water supply and sanitation were found to be vulnerable due to narrow roads, improper sewage systems and drastic increase in population. People have also constructed their houses and

**Figure 2: Narrow road of Indira Nagar Colony.**

- Roads are narrow and uneven.
- Unwanted scrap is littered on the roads.
- Illegal encroachments by ground-floor residents.
- Water-logging during heavy rains.
- Accessibility issues during emergencies due to road encroachments and low-hanging electrical wires.

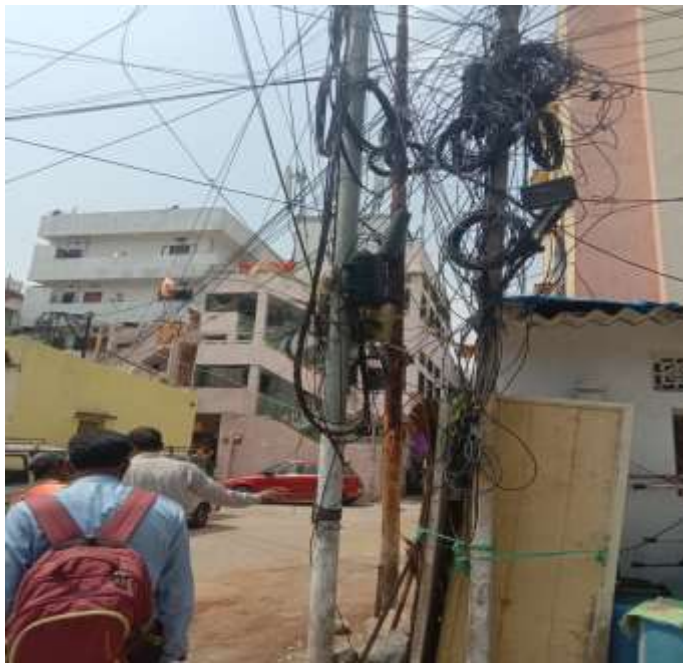
encroached roads according to their needs. There are also frequent power cuts in this area. The electric poles were rusted and electrical cables were observed to be clumsy.

**Figure 3: Clumsy electrical cables at Indira Nagar Colony.**

- Frequent power cuts are reported by the residents.
- Electric wires are chaotic and entangled.

- 1) Installation of new sewage lines or remoulding the existing sewage lines can be adopted to avoid stagnation of water and congestion problems.
- 2) The water supply pipeline should be monitored by increasing the water pressure flow for adequate supply to avoid usages of pumps.
- 3) The water supply pipeline alignment should be checked to avoid groundwater seepage and mixing of rainwater/ sewage water in drinking water.
- 4) Permeable concrete roads can be provided for the internal roads with proper rainwater harvesting pits.
- 5) To maintain the proper width of the roads, encroachments can be minimized or modified.
- 6) Power connections and cables are to be aligned in a strategic manner to avoid clumsiness.

- 7) Existing rusted electric poles can be replaced with new concrete poles and erecting proper earthing with guard wires.
- 8) Overhead power transmission lines are to be insulated with PVC casing pipes for safety of residents.
- 9) To provide accessibility to the residents, solar street lighting and CCTV cameras can be implemented to prevent accidents / thefts / safety during night times.
- 10) To reduce the consumption of electricity bill by the residents, it is proposed to install solar panels at dead spots.

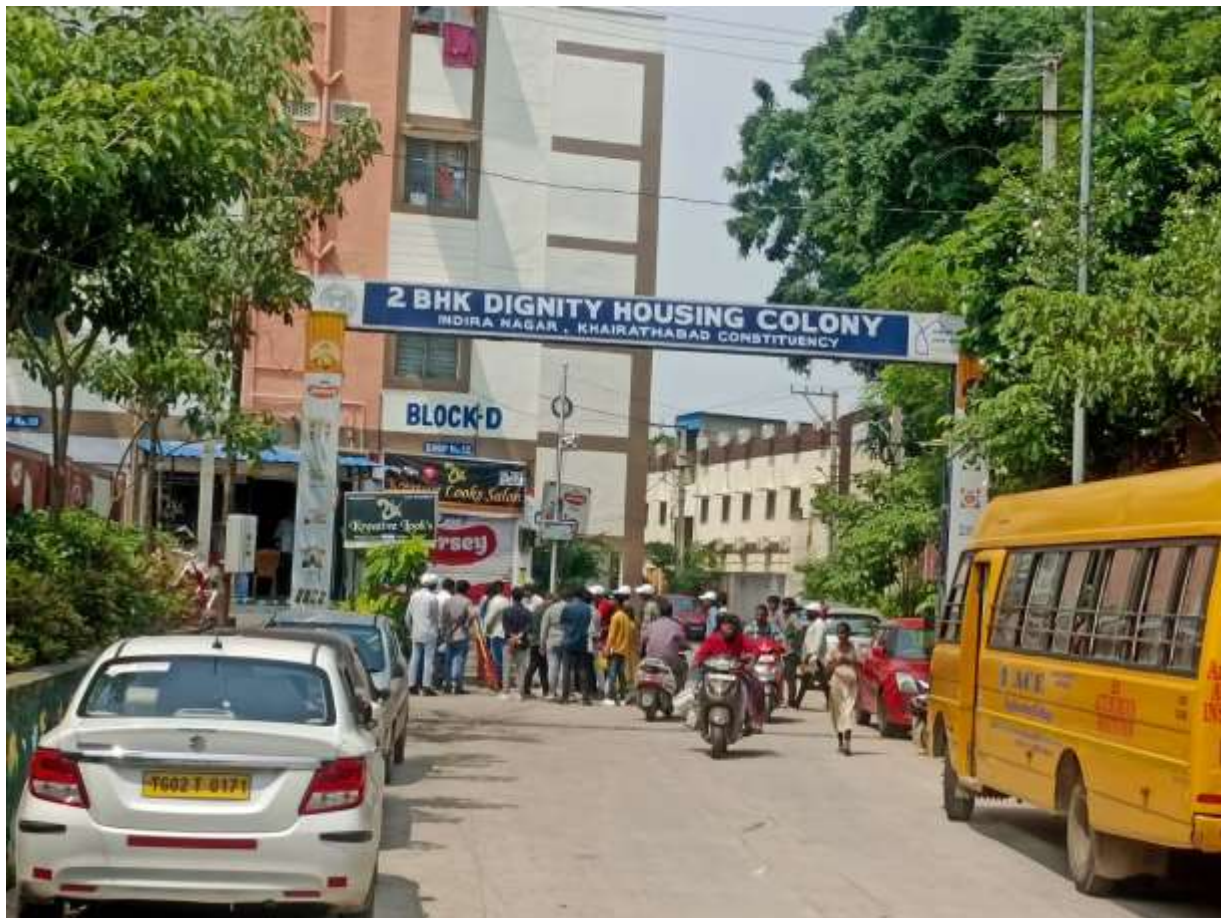
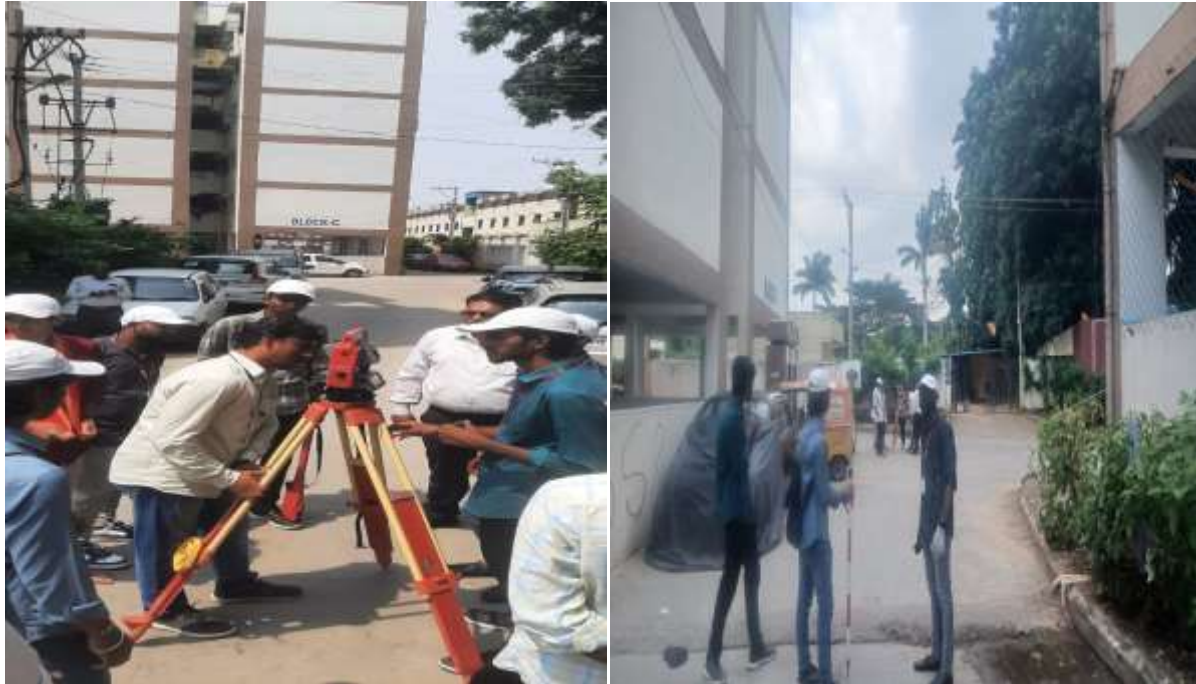
The students of **ACE Engineering College** has conducted a field survey to find the average levels of Indira Nagar Colony with reference to the surrounding area.

**Figure 6: Field Survey by students of ACE Engineering College**

1. Based on the levels taken, with reference to the Main Road (I Max road), the entire area of Indira Nagar Colony was found to be in a low-lying area.

4. It was observed that the road levels and house levels were almost at the same level due to which there is a possibility of rain water entering into the houses.

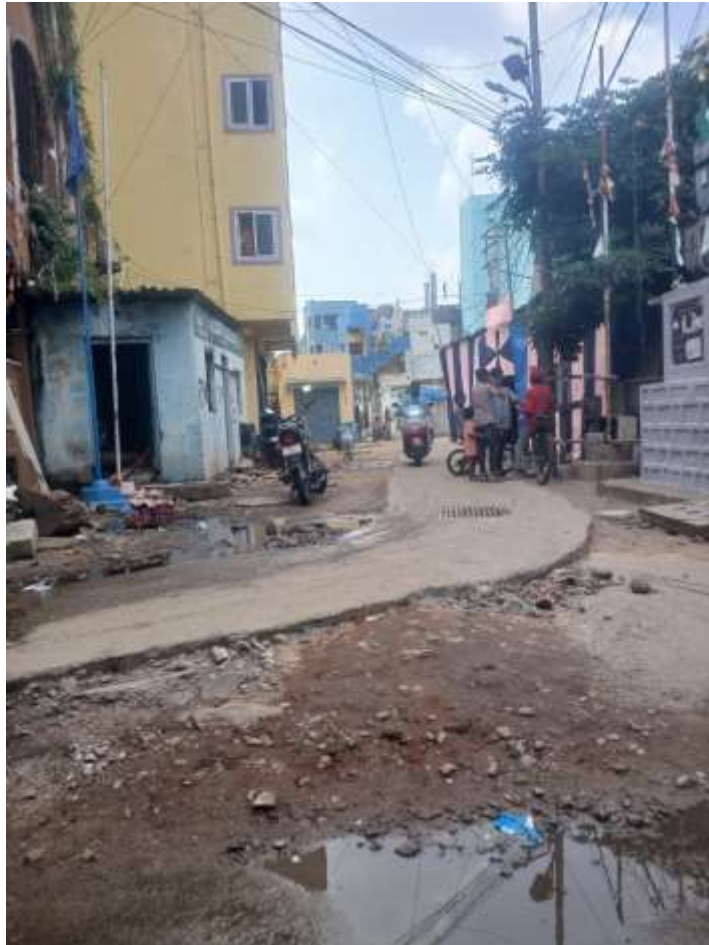
5. It was found that in addition to sewerage manholes, other manholes were constructed for rain water flow, due to which there is a very bad odour in the entire area.

6. As per the field observation, the flow of rain water manholes have been diverted into the sewerage manholes.
7. The majority of the houses in the colony are found to have chipped walls, crooked shutters and cracked floors.

**Figure 7: Additional Manholes**

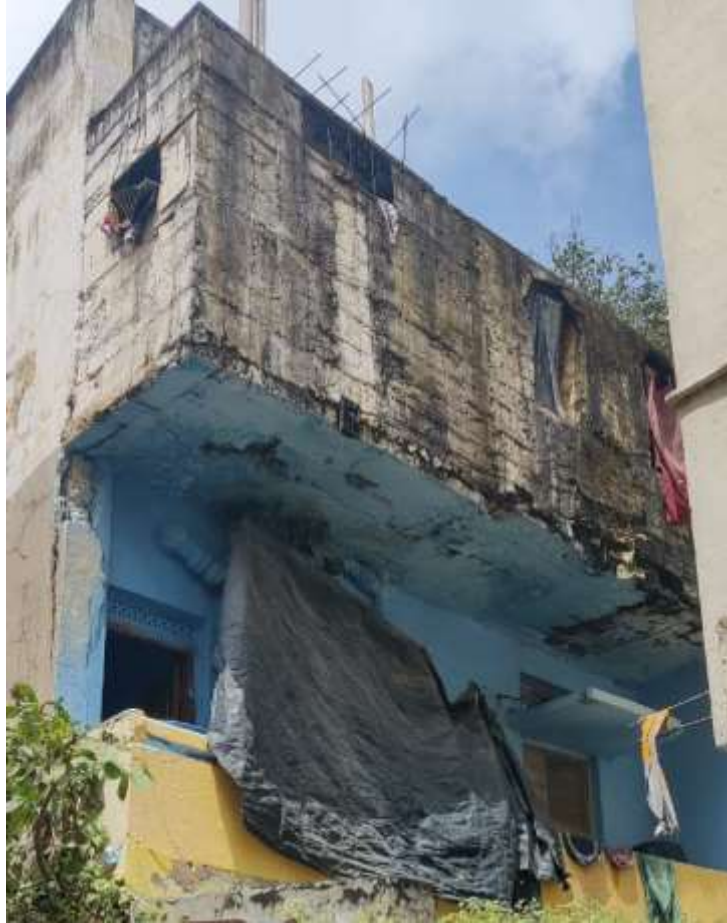
**Figure 8: Cracked floors and chipped walls**
