## **A GOVERNMENT INITIATIVE FOR SLUM REHABILITATION**

**at INDIRA NAGAR COLONY, KHAIRTABAD, HYDERABAD**

**( under Swachhata HI Seva - 2024)**

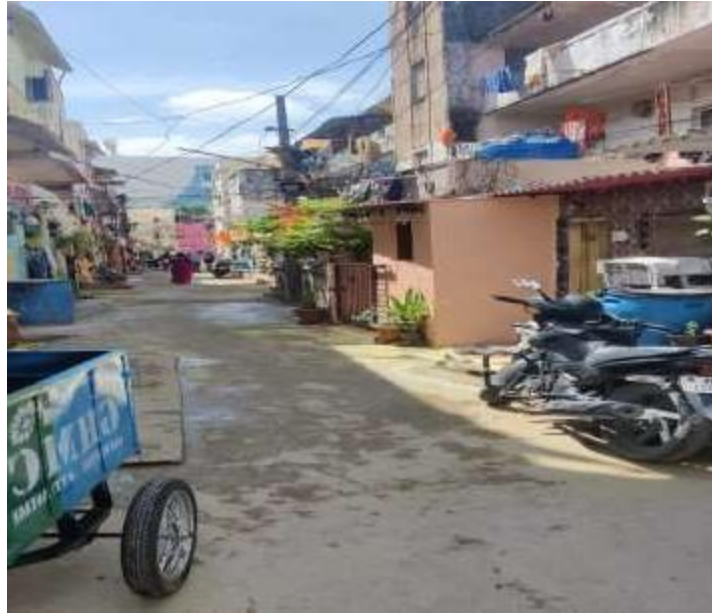
The condition of this area is poor and majority of the people live in kutcha and semi-pukka houses. The situation in terms of socio-economic condition and physical infrastructure namely water supply and sanitation were found to be vulnerable due to narrow roads, improper sewage systems and drastic increase in population. People have also constructed their houses and

**Figure 2: Narrow road of Indira Nagar Colony.**

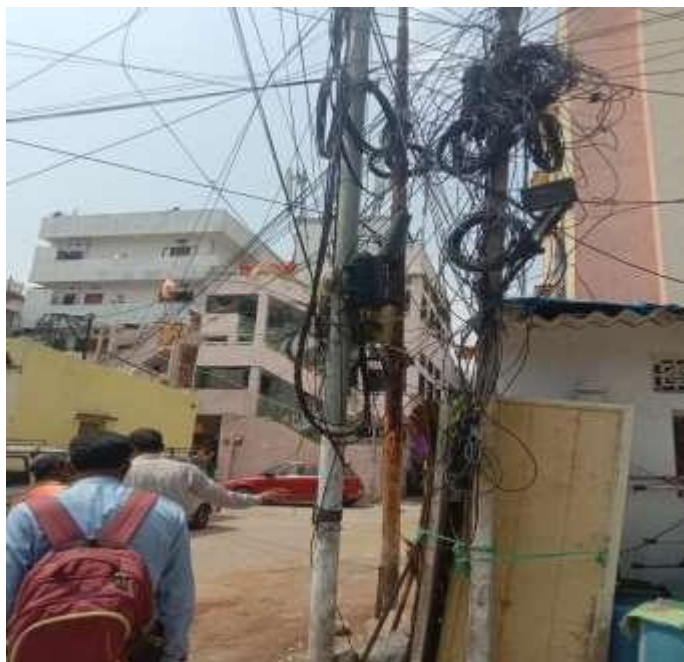
encroached roads according to their needs. There are also frequent power cuts in this area. The electric poles were rusted and electrical cables were observed to be clumsy.

**Figure 3: Clumsy electrical cables at Indira Nagar Colony.**

- Frequent power cuts are reported by the residents.
- Electric wires are chaotic and entangled.

- 1) Installation of new sewage lines or remoulding the existing sewage lines can be adopted to avoid stagnation of water and congestion problems.
- 2) The water supply pipeline should be monitored by increasing the water pressure flow for adequate supply to avoid usages of pumps.
- 3) The water supply pipeline alignment should be checked to avoid groundwater seepage and mixing of rainwater/ sewage water in drinking water.
- 4) Permeable concrete roads can be provided for the internal roads with proper rainwater harvesting pits.
- 5) To maintain the proper width of the roads, encroachments can be minimized or modified.
- 6) Power connections and cables are to be aligned in a strategic manner to avoid clumsiness.

- 7) Existing rusted electric poles can be replaced with new concrete poles and erecting proper earthing with guard wires.
- 8) Overhead power transmission lines are to be insulated with PVC casing pipes for safety of residents.
- 9) To provide accessibility to the residents, solar street lighting and CCTV cameras can be implemented to prevent accidents / thefts / safety during night times.
- 10) To reduce the consumption of electricity bill by the residents, it is proposed to install solar panels at dead spots.

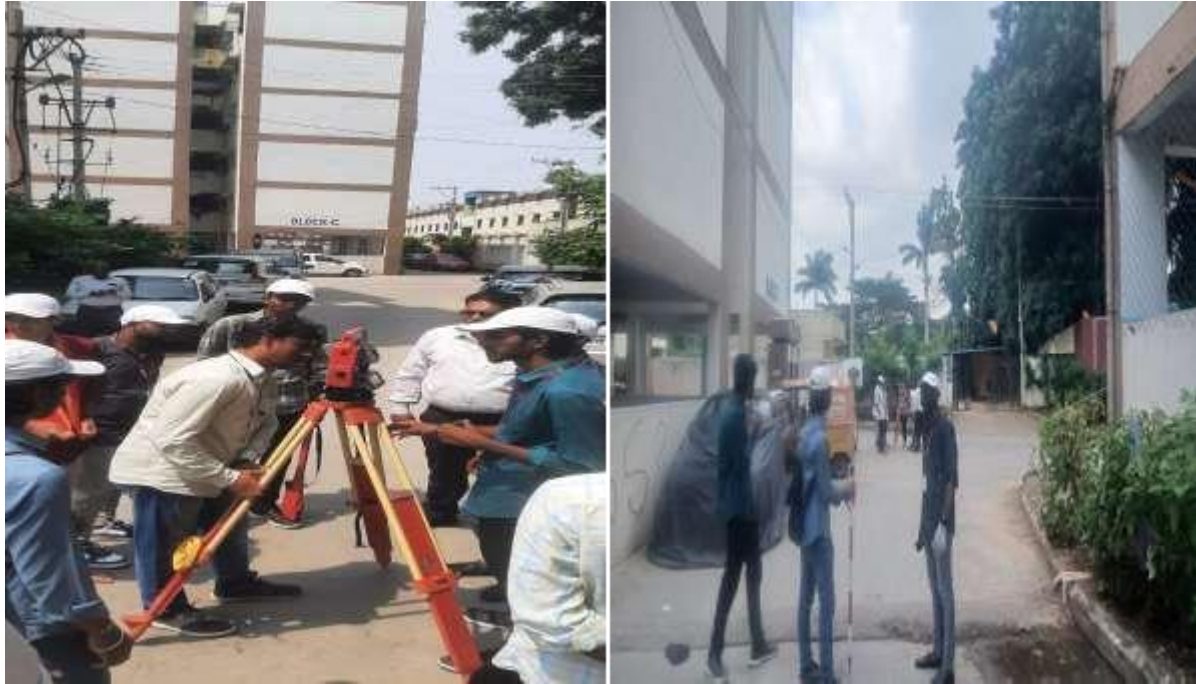
The students of **ACE Engineering College** has conducted a field survey to find the average levels of Indira Nagar Colony with reference to the surrounding area.

**Figure 6: Field Survey by students of ACE Engineering College**

1. Based on the levels taken, with reference to the Main Road (I Max road), the entire area of Indira Nagar Colony was found to be in a low-lying area.

4. It was observed that the road levels and house levels were almost at the same level due to which there is a possibility of rain water entering into the houses.

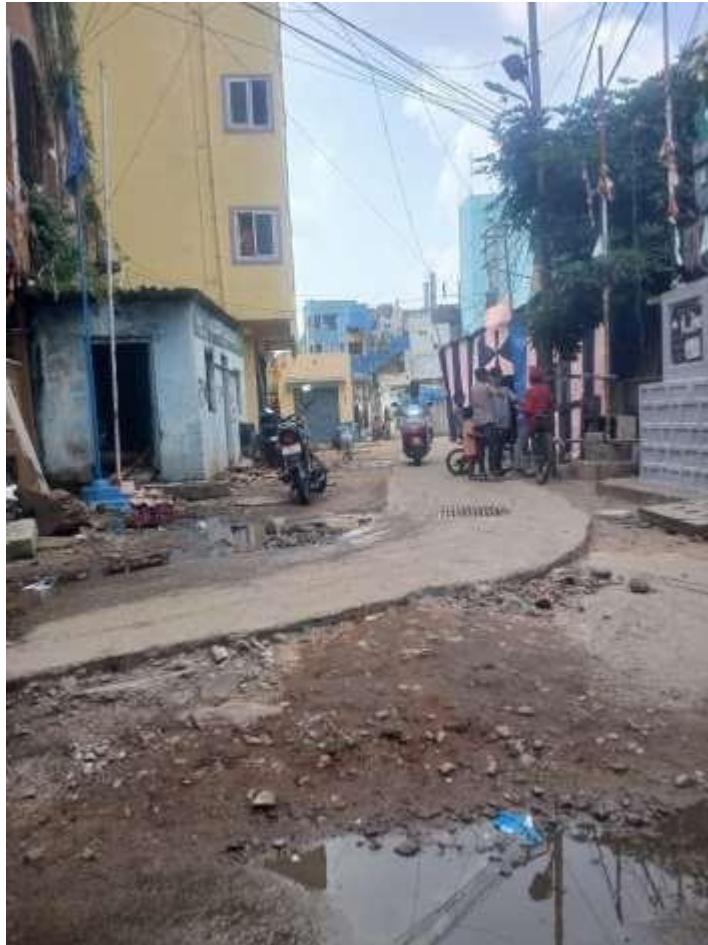
5. It was found that in addition to sewerage manholes, other manholes were constructed for rain water flow, due to which there is a very bad odour in the entire area.

6. As per the field observation, the flow of rain water manholes have been diverted into the sewerage manholes.
7. The majority of the houses in the colony are found to have chipped walls, crooked shutters and cracked floors.

**Figure 7: Additional Manholes**

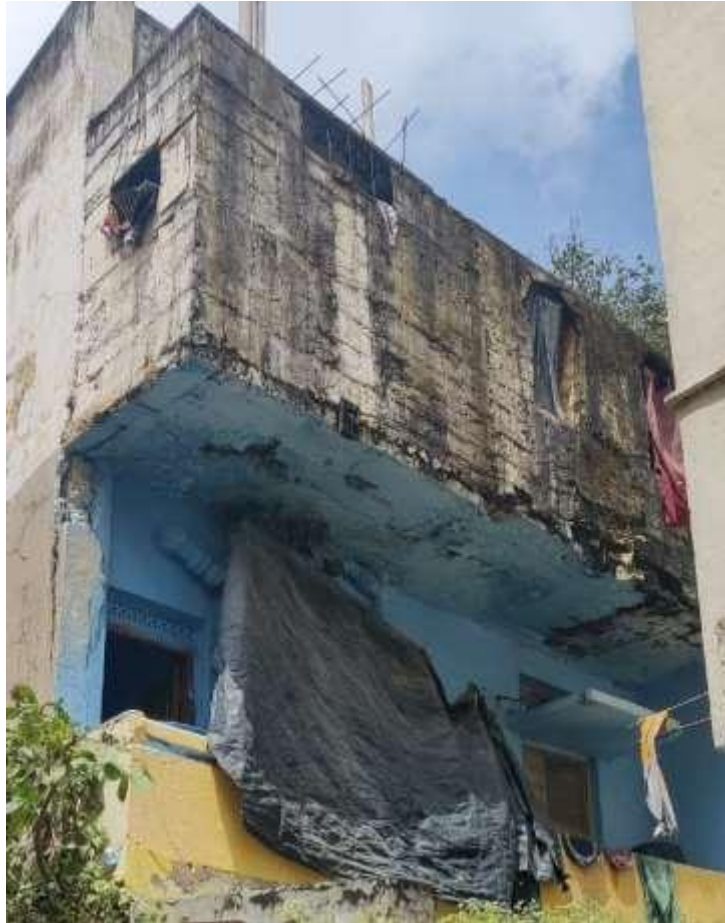
**Figure 8: Cracked floors and chipped walls**
